CIVIL WAR RECONSTRUCTION COMMISSION  
INVENTORY - NOTIFICATION FORM

PUBLIC SCHOOL #99 (preferred); The Columbus School

NATIONAL REGISTER OF HISTORIC PLACES  
INVENTORY--NOMINATION FORM

PUBLIC SCHOOL #99

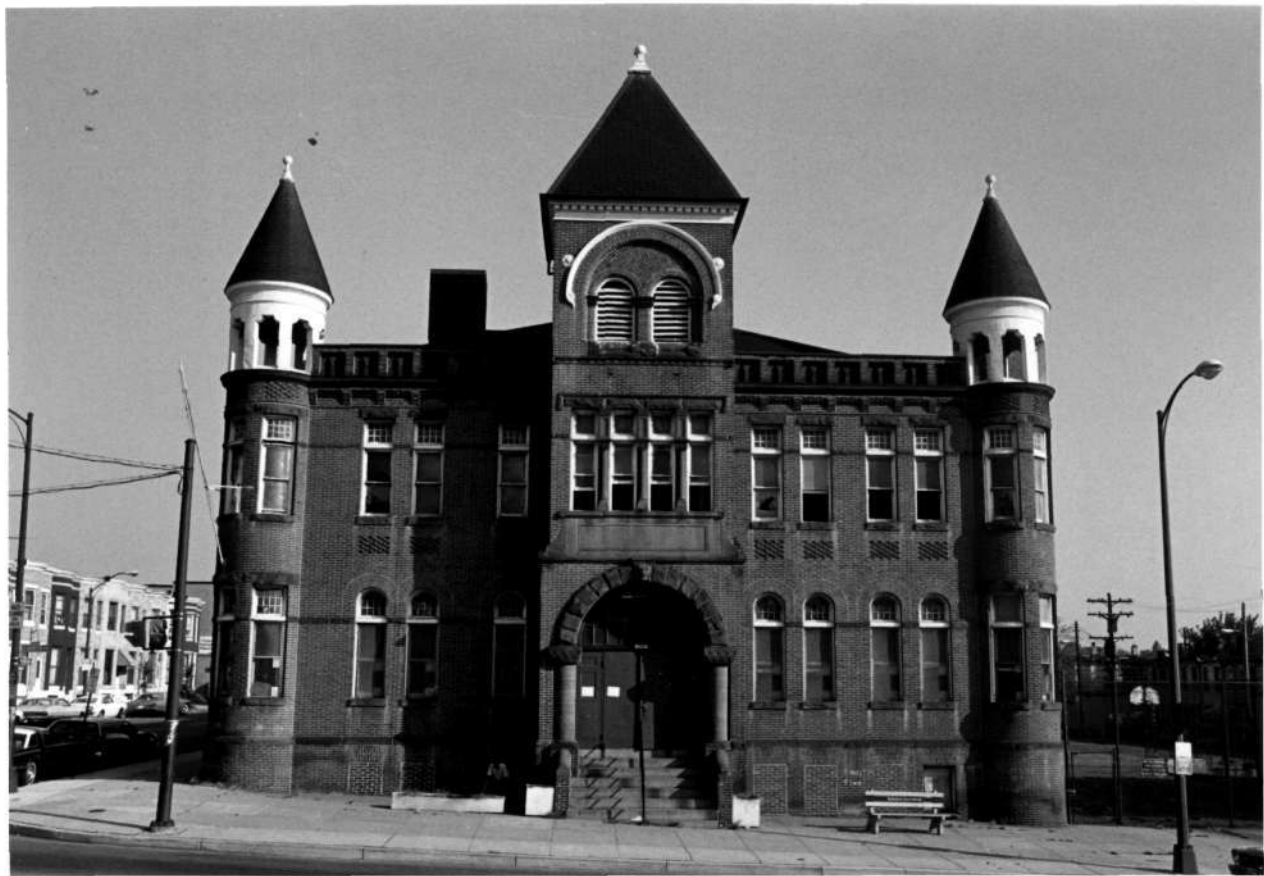
Front facade from North Avenue

The two-story, eleven bay wide building is defined by the corner towers and large three-story central tower. Large wooden double doors with side wooden panels on the tower facade surmount seven stone steps and brick cheek walls with stone covering. This entrance, recessed into a large stone arch supported by two columns with decorative capitals, is ornamented with a lion's head keystone. A large multi-paned, semi-circular transom surmounts the double doors. Above the archway is a large stone with a decorative outline. Four one-over-one windows with single light transoms are divided by three stone pilasters. The windows have stone sills and lintels. The second and third story levels are divided by a stone band course. A large stone lintel is surmounted by louvered semi-circular windows set into a blind archway with gauged brick voussoirs. A wooden arch, painted white, encloses the two windows. Round stone ornamentation at the spandrels displays star designs. The tower facade is capped with a dentiled wooden cornice, metal roof gutter, and large pyramidal slate roof with ball finials.

The flanking wall east of the tower is four bays wide, while the west flanking wall is three bays wide. Both sides are designed similarly. Basement windows with gauged brick lintels punctuate the foundation walls and are surmounted by a stone water table. Windows on the first floor have one-over-one sash with a semi-circular multi-paned transom and gauged semi-circular arched brick lintels. The windows have stone sills, and a stone band course travels along the walls at the top rail level of the windows. Recessed rectangular brick panels decorate the walls between the first and second stories. The second story windows have one-over-one sash with a twelve-light transom, walls at the top rail level of the windows. The building walls are capped by corbeled brick and a metal roof gutter. A brick parapet rising above the walls is decorated with corbeled openings and topped by a metal cap.

The round cylindrical towers each have six windows identical to the second story windows on the building walls. The towers rise above the cornice, ending in conical roofs. Eight openings defined by pilasters punctuate the towers above the building's roof line. A flag pole is hung from the western cylindrical tower.

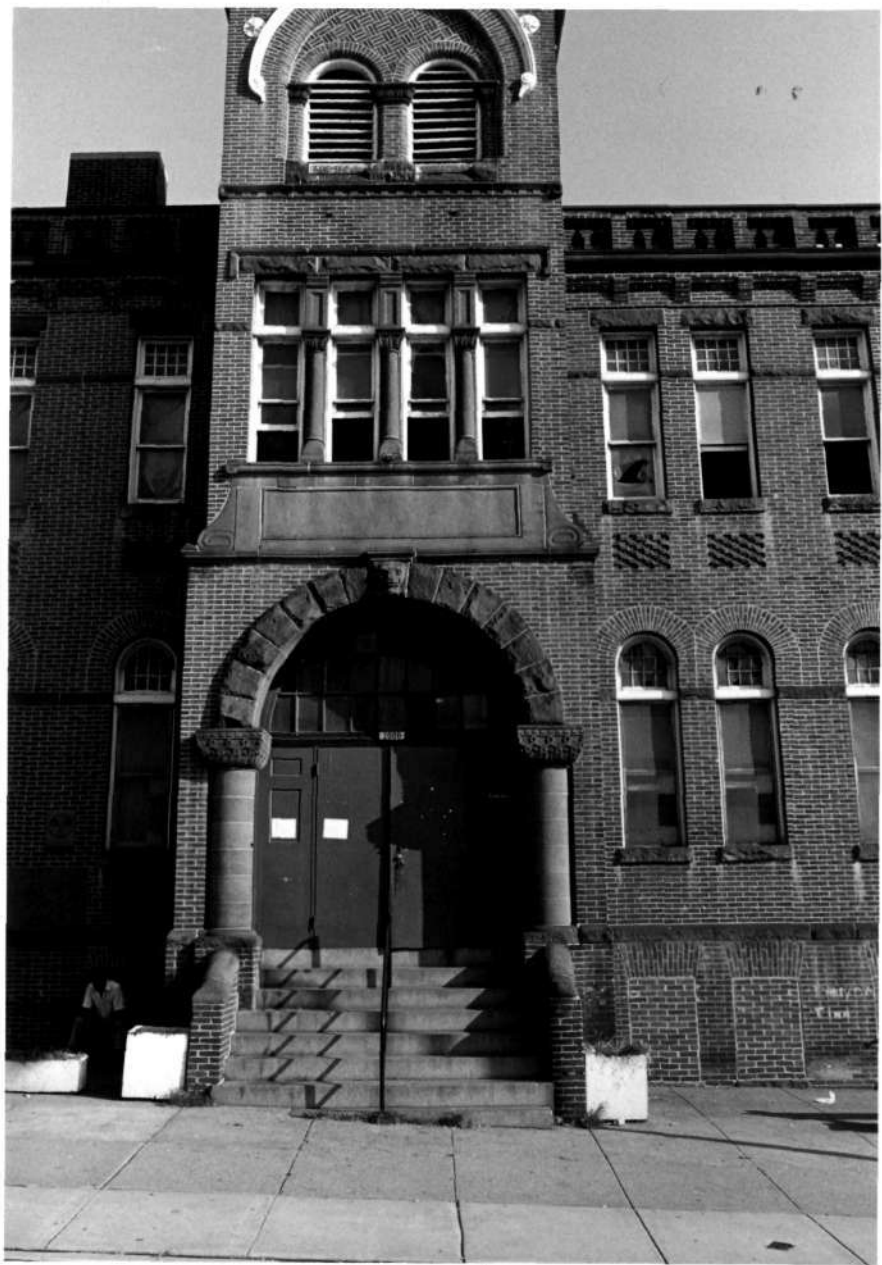
Front entrance detail

decorative caps, and ornamented with a lion's head keystone. A large round arched multi-paned transom fan light surmounts the double doors. Four first floor 1/1 windows with single light transoms are divided by three stone pilasters. The second and third floor levels are defined by a stone belt course. A heavy stone lintel is surmounted by louvered semi-circular windows set in a blind arcade with gaged brick voussoirs. A wood framed arch encloses the two windows. Round stone ornamentation at the spandrels have star design reliefs. The tower pavilion is capped by a dentilled wood cornice, metal gutter and large pyramidal slate roof with ball finials.

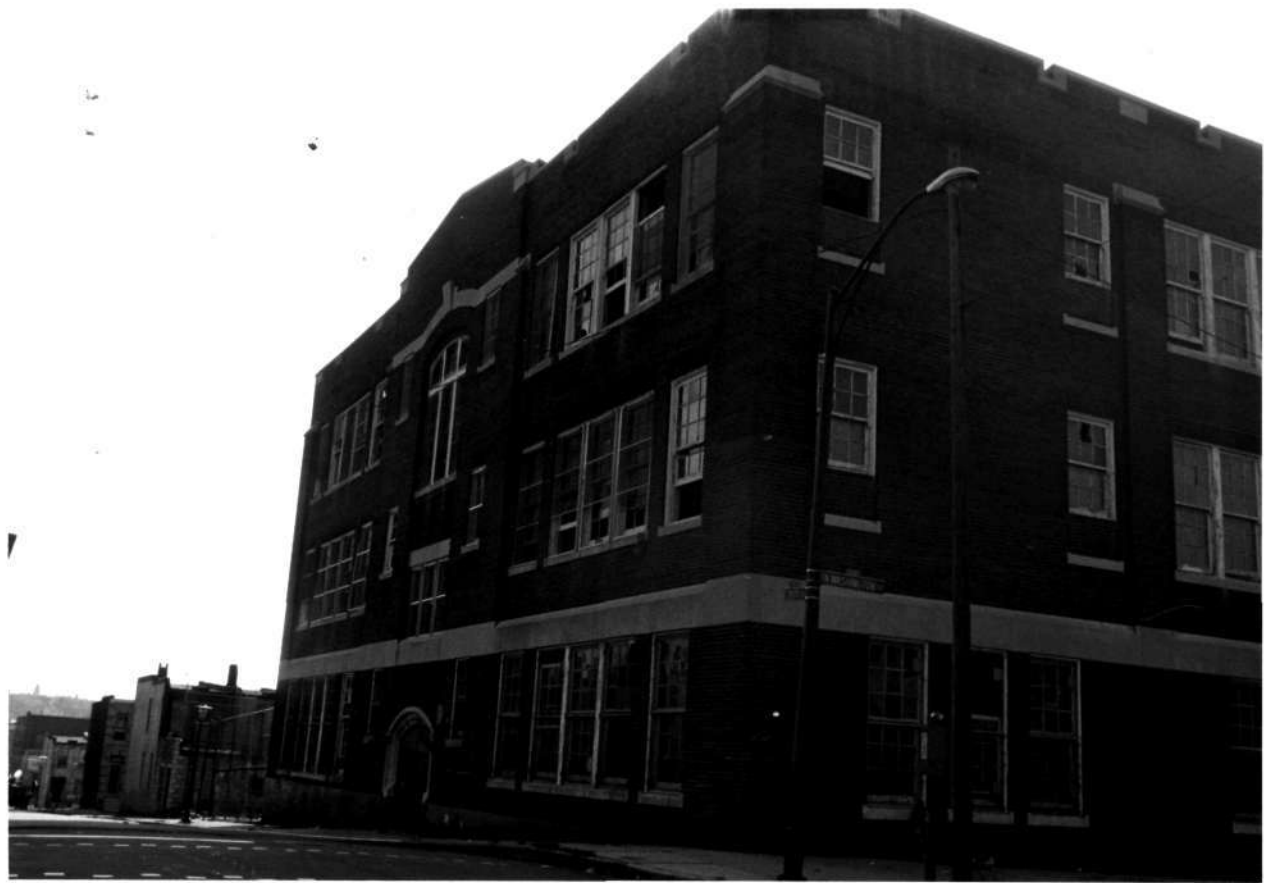
Rear section facade

The rear addition is seven bays wide, constructed of dark brick, and three stories high. It is defined by three piers with smooth stone capitals. The south section has five nine-over-nine windows grouped together on the second and third floor levels. They have a shared stone sill and gauged brick lintel. The northern section has two taller windows on the second and third stories. Both first stories have three nine-over-nine windows on each side, directly below a wide stone band course. The building walls are capped in crenelated stone molding.

The rear of the second addition is defined by a central entrance section projecting slightly and ending in a shallow pediment. It has a wide entrance on the first floor and a large window at the third floor level. The flanking walls are five bays wide. The outer windows are nine-over-nine with a stone sill and brick lintel. The central windows are tri-partite nine-over-nine with shared sills and lintels. The building walls end in crenelated stone molding.

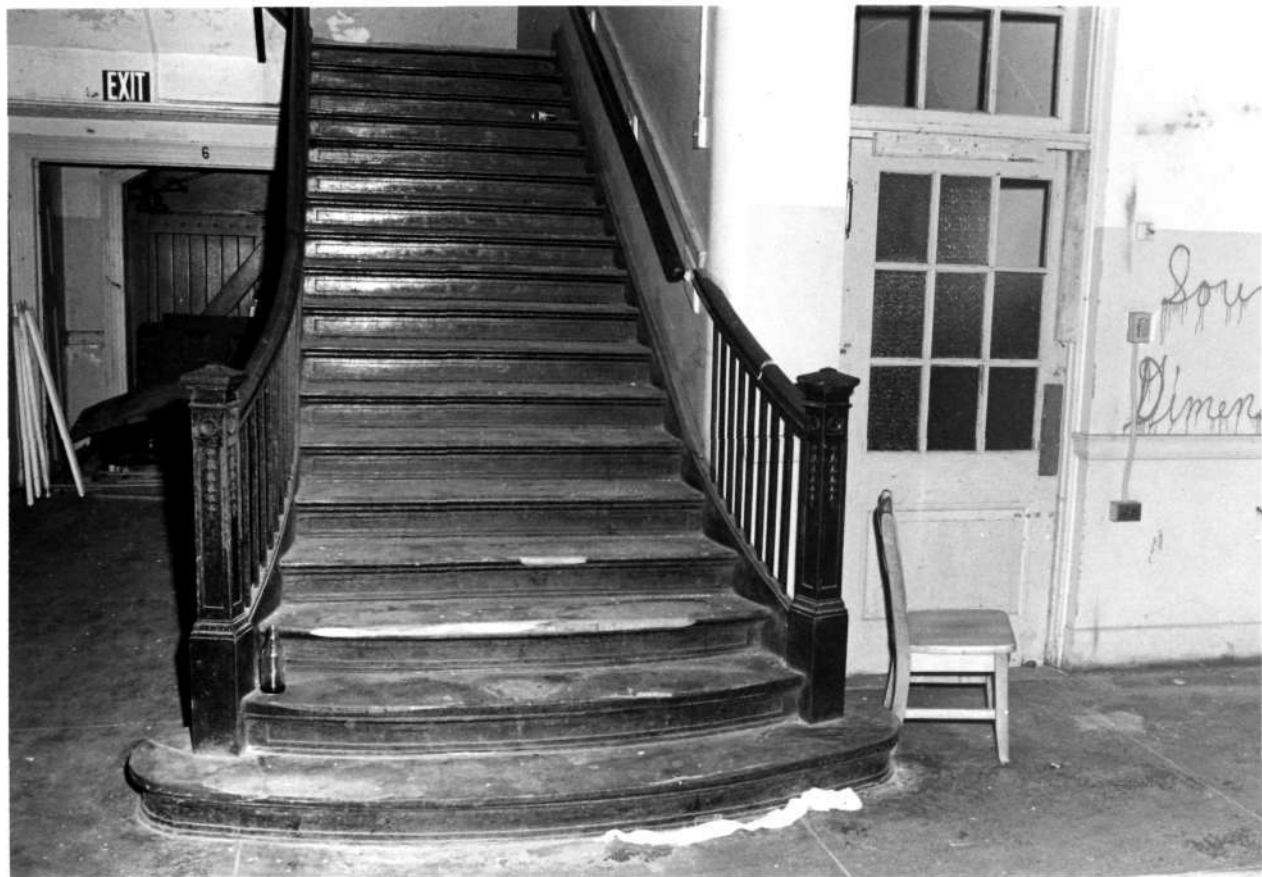
Rear Section Stairway

The school's interior has a simple plan of classrooms flanking a central corridor which bends at the connecting walls of each section and ends in a T-shape in the rear addition. Main stairways are located in the connecting section between the original building and first addition and at the center of the rear addition. The interior's most notable characteristics include metal ceilings in many classrooms and the halls of both additions, interior windows (many of them have been painted over) in the original building section, and the large staircase with wooden handrails in the rear addition. The corner rooms facing the front have an unusual shape incorporating the round tower walls.

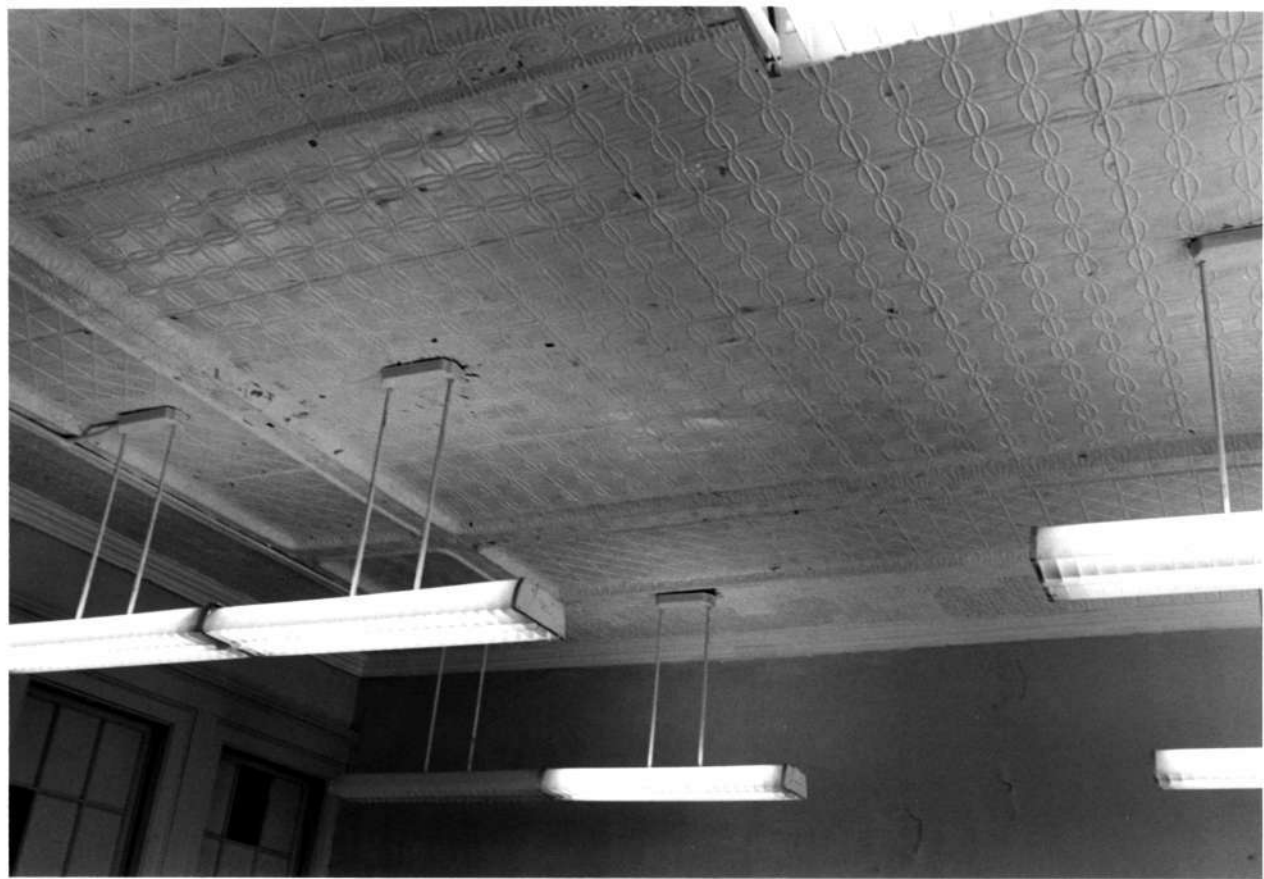
Tin ceiling in classroom

The Columbus School is an example of the best of Romanesque Revival architecture in Baltimore. The central pyramidal tower and end turrets are highly visible on North Avenue, a major traffic corridor. Built in three different stages, it represents the changing quality of school construction in the late nineteenth and early twentieth centuries. The interior metal ceilings are rare for Baltimore City schools.

The interior has classrooms flanking a central corridor that turns at the first addition and terminates in a "T" at the last addition. Main stairs are located in the hyphen that connects the original and first addition and at the center of the rear addition. The interior has excellent pressed metal ceilings in many classrooms and in the hall.
